Stream and Riparian Habitat in the Lower Coos Watershed

Summary:

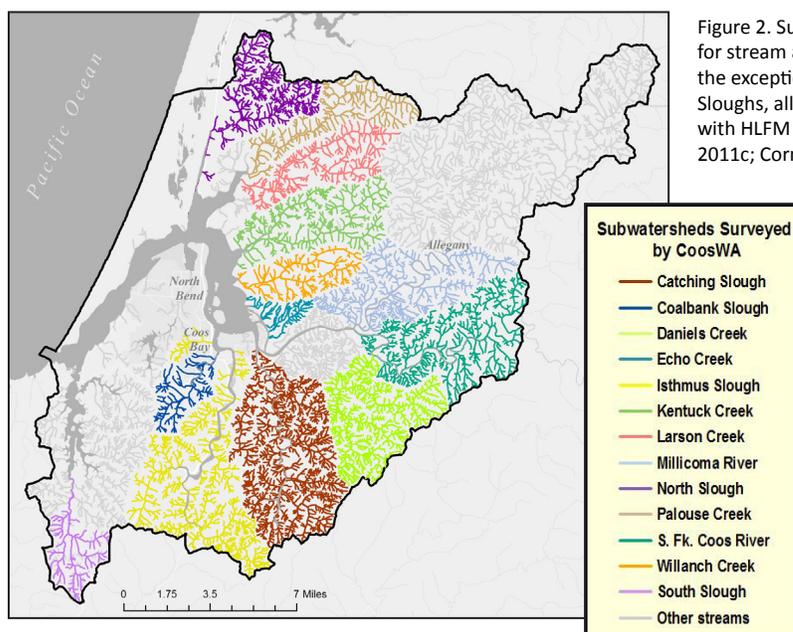
Figure 2. Subwatersheds evaluated by CoosWA for stream and riparian habitat surveys. With the exception of South, Isthmus, and Coalbank Sloughs, all drainage basins were also evaluated with HLFM modeling. Data: CoosWA 2006, 2008, 2011c; Cornu et al. 2012

2011c)(Figure 2). Oregon Department of Fish and Wildlife (ODFW 2013) habitat surveys within the project area from 1998 to 2013 are included for comparison (Figure 3). Where data from other sources are used, it is noted in the text. Key ODFW and United States Environmental Protection Agency (USEPA) stream habitat benchmarks are listed in the sidebar (next page). The Background section provides additional information about the habitat features discussed in this section.

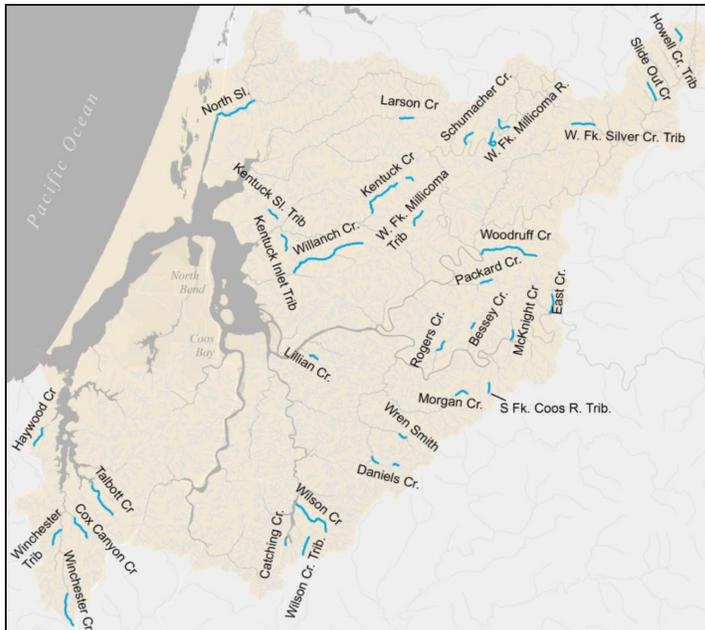
Figure 3. General locations of stream reaches surveyed by ODFW 1998-2013 (in blue) within the project area. Location of reach within the stream and reach lengths are approximate. Orange shading indicates the project area. Data: ODFW 2013

By contrast, of nearly 40 reaches evaluated by ODFW during 1998-2013 summer surveys in the project area (Figure 3), 28% (11) exceeded the preferred benchmark, 51% (20) met the minimum benchmark, and 21% (8) failed to meet either benchmark. ODFW data indicate an average pool area per reach of nearly 29%, but as Figure 5 indicates, the average conceals a wide variation range, from 0% pool area to nearly 100%. If anything, the average may be slightly biased in favor of high pool content by a few reaches with exceptionally high content (the median, by contrast, is a somewhat more modest 23%).

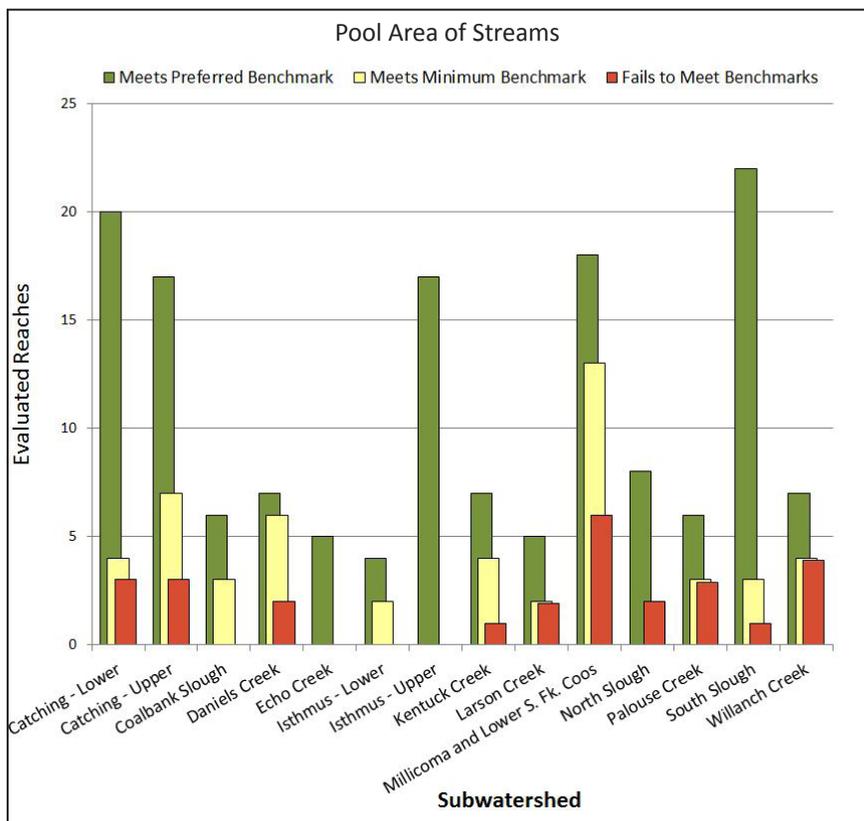
Figure 4. Distribution of evaluated stream reaches in the project area that met, exceeded, or did not meet ODFW habitat benchmarks for pool area of streams. Data: CoosWA 2006, 2008, 2011c; Cornu et al. 2012

Of 227 project area stream reaches evaluated by CoosWA, nearly 66% (149) met or exceeded the ODFW preferred benchmark, 22% (51) met the minimum benchmark, and 12% (27) failed to meet any benchmark (Figure 4).

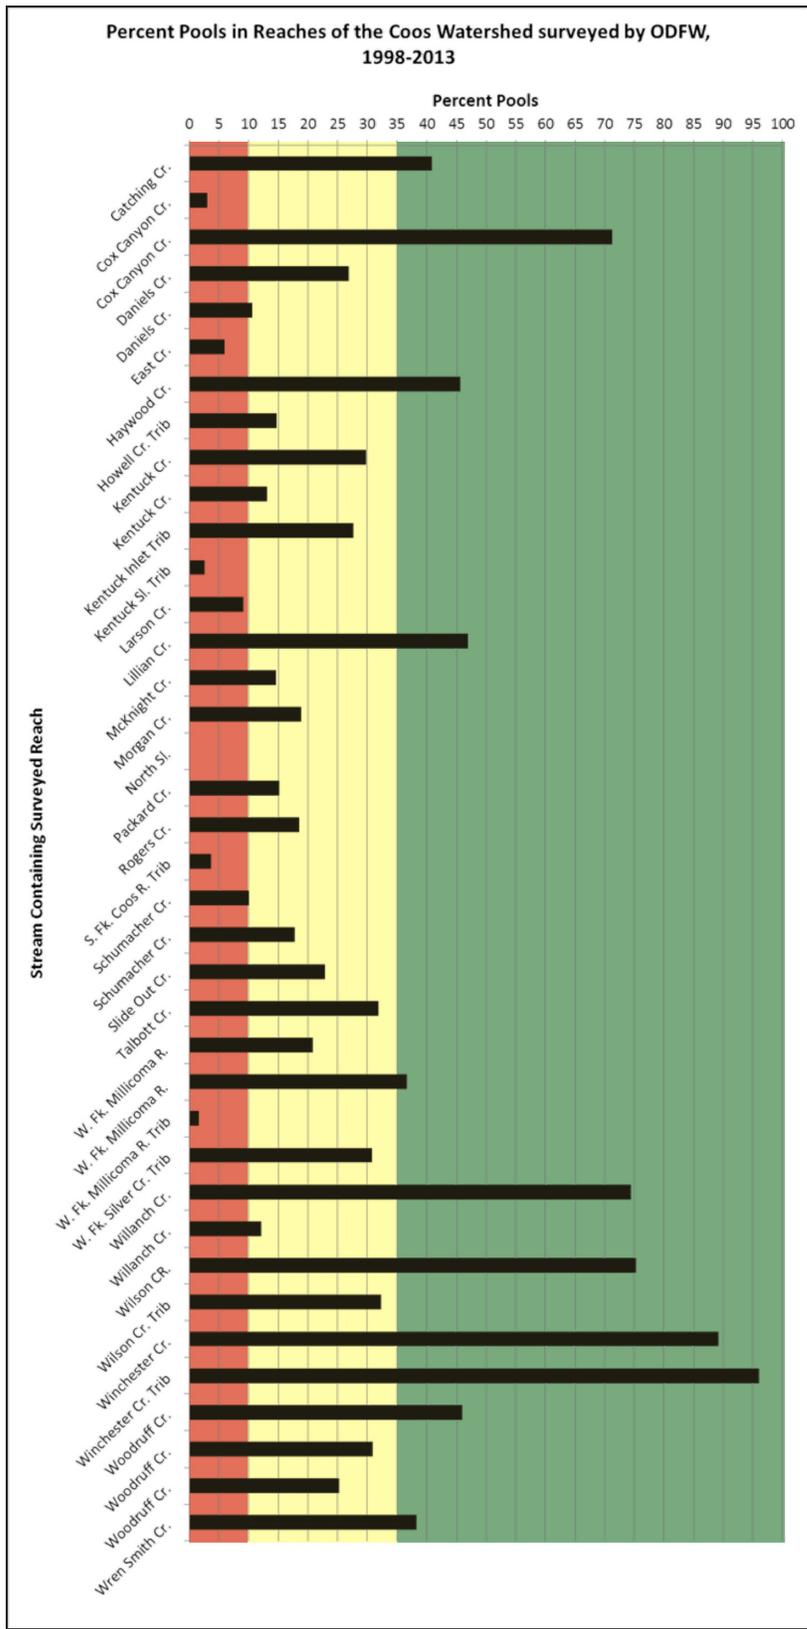
Figure 5. Percentage of pools in surveyed stream reaches of the lower Coos watershed during summers 1998-2003. Stream reaches surveyed across multiple years were averaged. Repeat stream reach names indicates more than one distinct reach on that named stream was surveyed. Graph background colors: Red zone- reach did not meet the 10% minimum benchmark; Yellow zone- reach met the minimum benchmark but did not meet >35% preferred benchmark; Green zone- reach met or exceeded the preferred benchmark of >35%. Data: ODFW 2013.

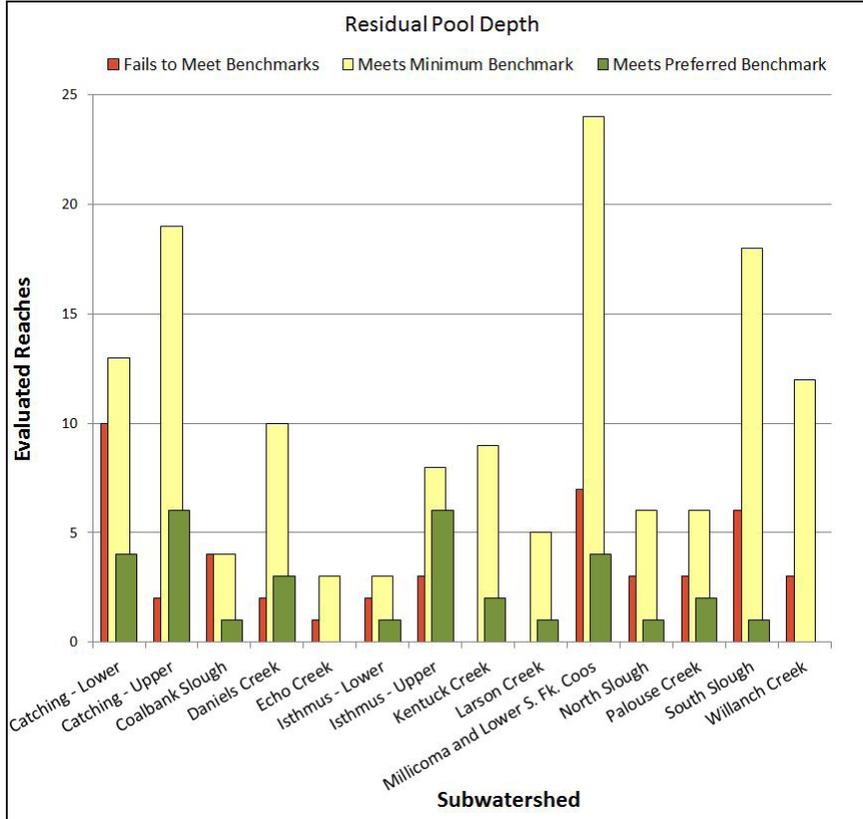
Figure 6. Distribution of evaluated stream reaches in the project area that met, exceeded, or did not meet ODFW habitat benchmarks for residual pool depth. Data: CoosWA 2006, 2008, 2011c; Cornu et al. 2012

benchmark is 0.3 m (1 ft), while 0.6 m (2 ft) or deeper is the preferred depth (OCSRI 1997). While a sizable majority of stream reaches evaluated by the CoosWA met or exceeded the minimum and preferred pool area benchmarks, residual pool depth in those same reaches was not as impressive (Figure 6). Of 218 reaches analyzed, 64% (140) met the minimum residual pool depth benchmark; 21% (46) failed to meet the minimum benchmark. Only 15% (32) of the reaches met the preferred benchmark. The Lower Catching Slough, in particular, had the most pools fail to meet any benchmarks for residual pool depth.

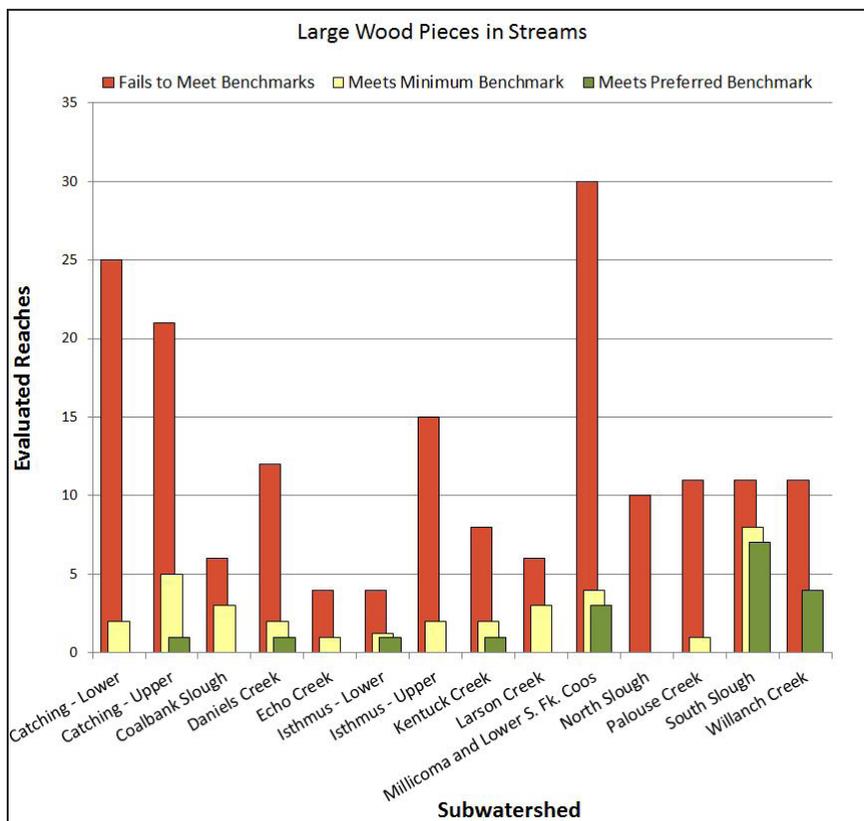
Figure 7. Distribution of evaluated stream reaches in the project area that met, exceeded, or did not meet ODFW habitat benchmarks for LWD pieces in streams. Data: CoosWA 2006, 2008, 2011c; Cornu et al. 2012

As shown in Figure 7, of 226 stream reaches evaluated by the CoosWA, 8% (18) met the preferred benchmark, 15% (34) met the minimum benchmark, and 77% (174) did not meet either benchmark. Of particular note is the North Slough watershed, which did not have a single surveyed reach that met the minimum benchmark for large wood pieces. In every subwatershed, reaches not meeting either benchmark outnumbered those that did.

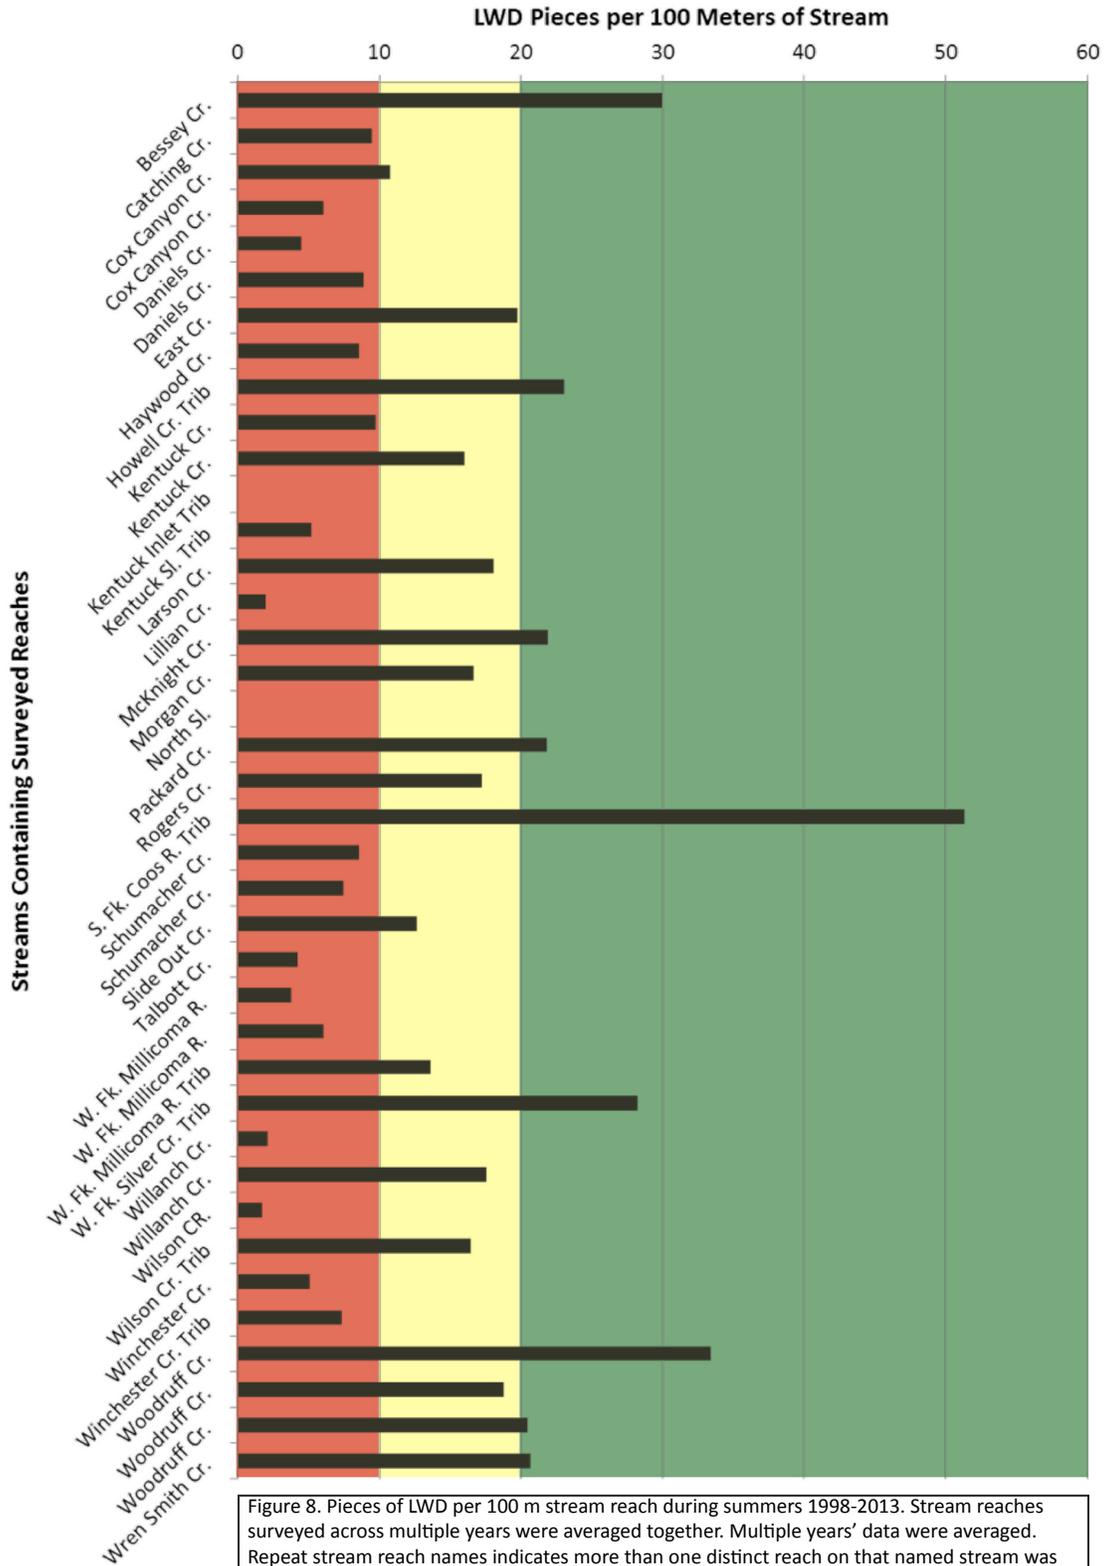
Pieces in Coos Watershed Reaches Surveyed By ODFW, Summers 1998-2013

Figure 8. Pieces of LWD per 100 m stream reach during summers 1998-2013. Stream reaches surveyed across multiple years were averaged together. Multiple years' data were averaged. Repeat stream reach names indicates more than one distinct reach on that named stream was surveyed. Graph background colors: Red zone- reach did not meet the 10 pieces/100 m of stream minimum benchmark; Yellow zone- reach met the minimum benchmark but did not meet >20 pieces preferred benchmark; Green zone- reach met or exceeded the preferred benchmark of >20 pieces /100 m of stream. Data: ODFW 2013.

Summer surveys conducted by ODFW (Figure 3) paint a slightly different picture, as shown in Figure 8. In these surveys, 23% of surveyed reaches (9 of 39) met the preferred benchmark, 28% (11) met the minimum benchmark, and 49% (19) failed to meet the minimum benchmark. This difference may reflect minimal overlap between the reaches surveyed by ODFW and those surveyed by the CoosWA since CoosWA's surveys were focused on lower watershed tributaries only. Even so, nearly half the ODFW surveyed reaches do not meet the minimum standard for pieces of LWD per 100 meters of stream. Additionally, both surveys document a distinct lack of LWD in project area streams.

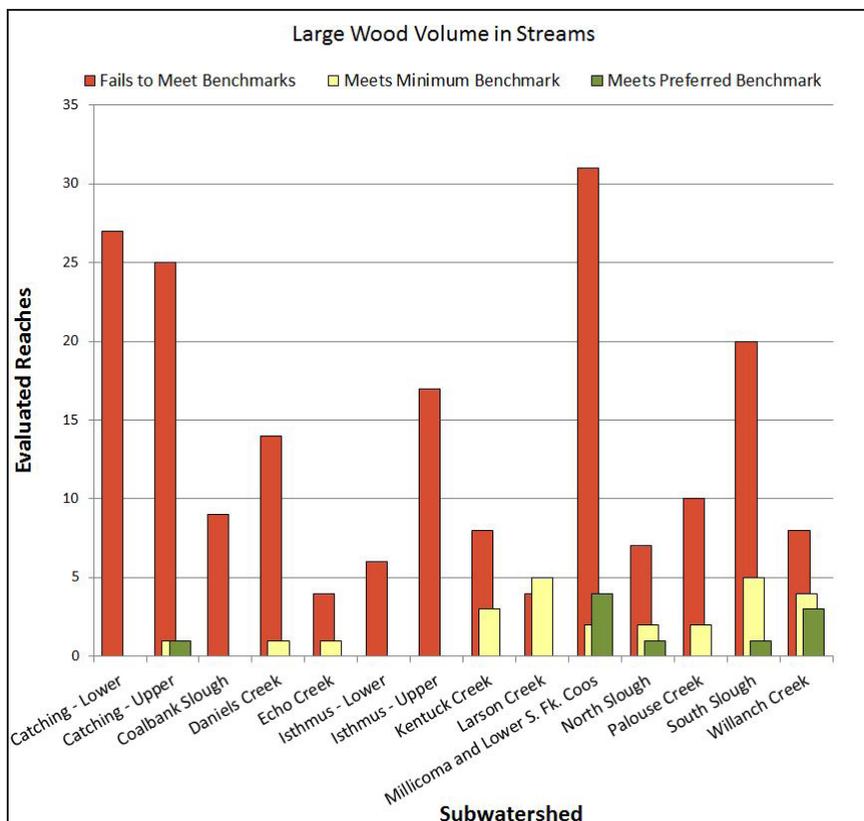
Figure 9. Distribution of evaluated stream reaches in the project area that met, exceeded, or did not meet ODFW habitat benchmarks for volume of LWD in streams. Data: CoosWA 2006, 2008, 2011c, Cornu et al. 2012

As shown in Figure 9, of 226 reaches evaluated by the CoosWA for wood volume in streams, 4% (10) met the 30 m³ per 100 m stream reach preferred benchmark, 12% (26) met the 20 m³ per 100 m stream reach minimum benchmark, and 84% (190) failed to meet either benchmark. Of particular note are Coalbank, Lower Catching, and Upper and

Lower Isthmus subwatersheds, within which not a single evaluated reach met the minimum benchmark.

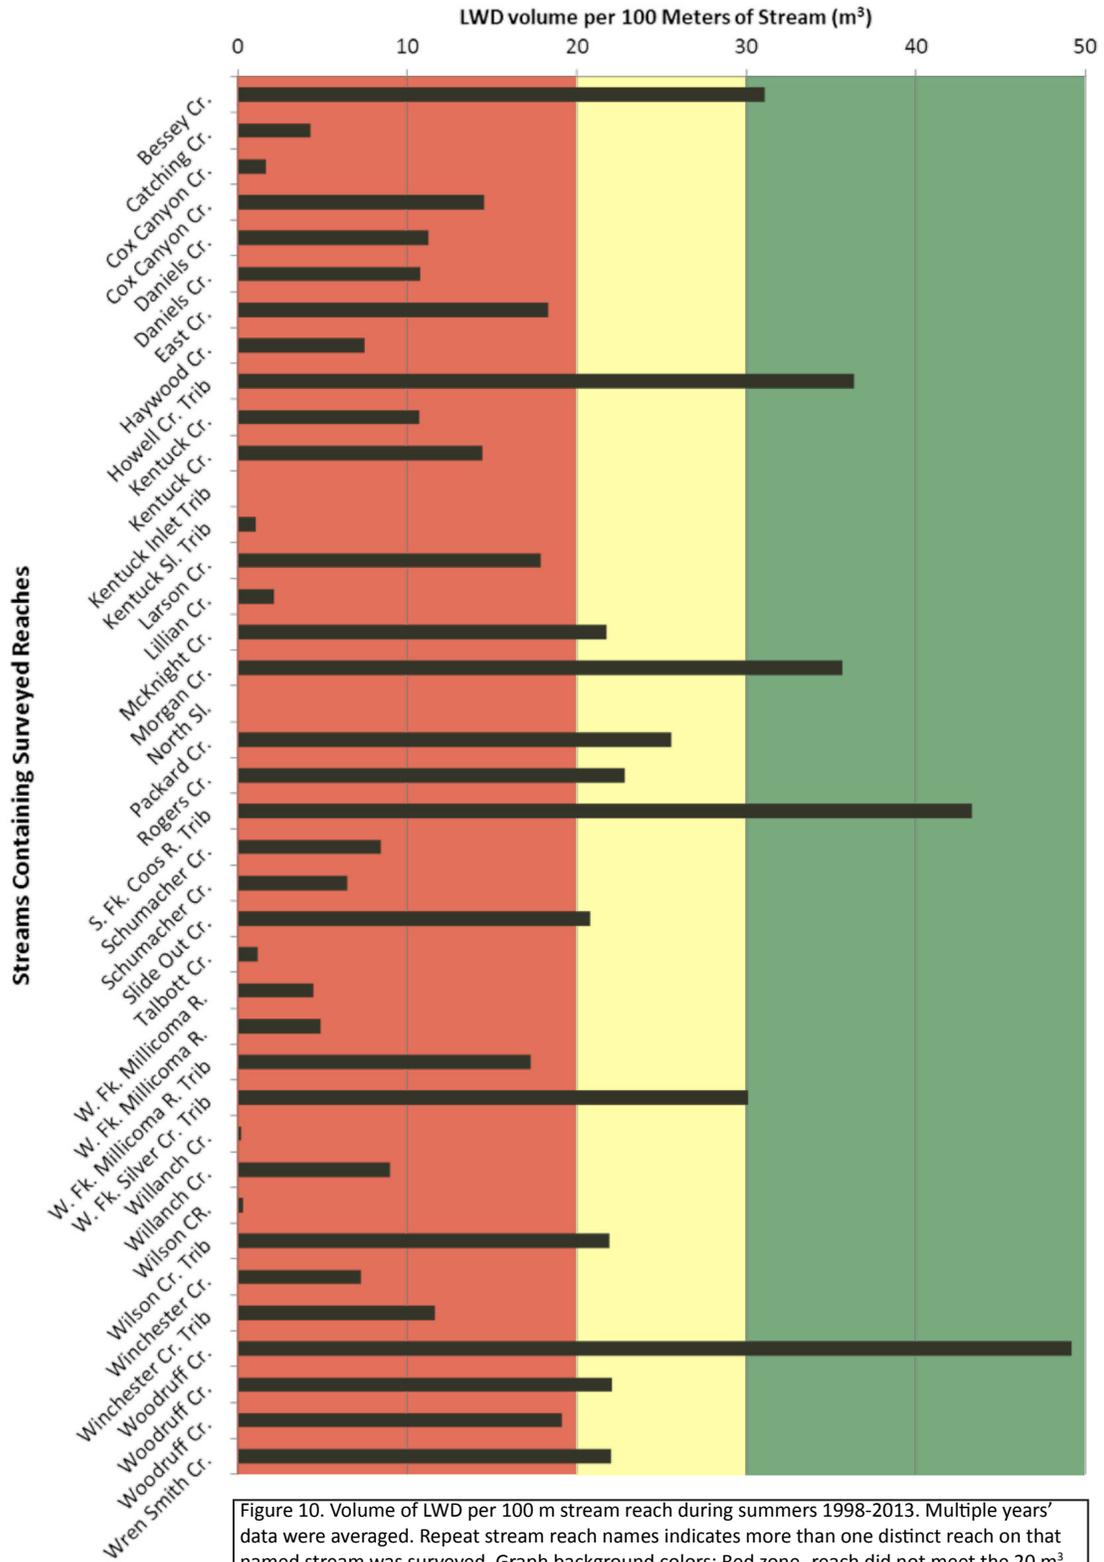
LWD Volume in Coos Watershed Reaches Surveyed By ODFW, Summers 1998-2013

Figure 10. Volume of LWD per 100 m stream reach during summers 1998-2013. Multiple years' data were averaged. Repeat stream reach names indicates more than one distinct reach on that named stream was surveyed. Graph background colors: Red zone- reach did not meet the 20 m³ minimum benchmark; Yellow zone- reach met the 20 m³ minimum benchmark but did no meet >30 m³ preferred benchmark; Green zone- reach met or exceeded the >30 m³ benchmark. Data: ODFW 2013.

ODFW 1998-2013 survey results indicate more wood volume than CoosWA surveys with 15% (6 of 39) of surveyed stream reaches meeting the preferred benchmark, 18% (7) of reaches meeting the minimum benchmark, and 67% (26) of reaches failing to meet either benchmark (Figure 10). Both CoosWA and ODFW surveys further highlight the alarming lack of wood volume in project area streams.

ODFW's LWD volume results averaged 15 m³/100 m stream reach (median: nearly 12 m³/100 m). But these data are highly variable, ranging from 0 to 49 m³/100 m. No LWD was found in Kentuck Inlet Trib or North Slough. The highest volume was found in Woodruff Cr, where it easily exceeded ODFW's preferred LWD volume benchmark.

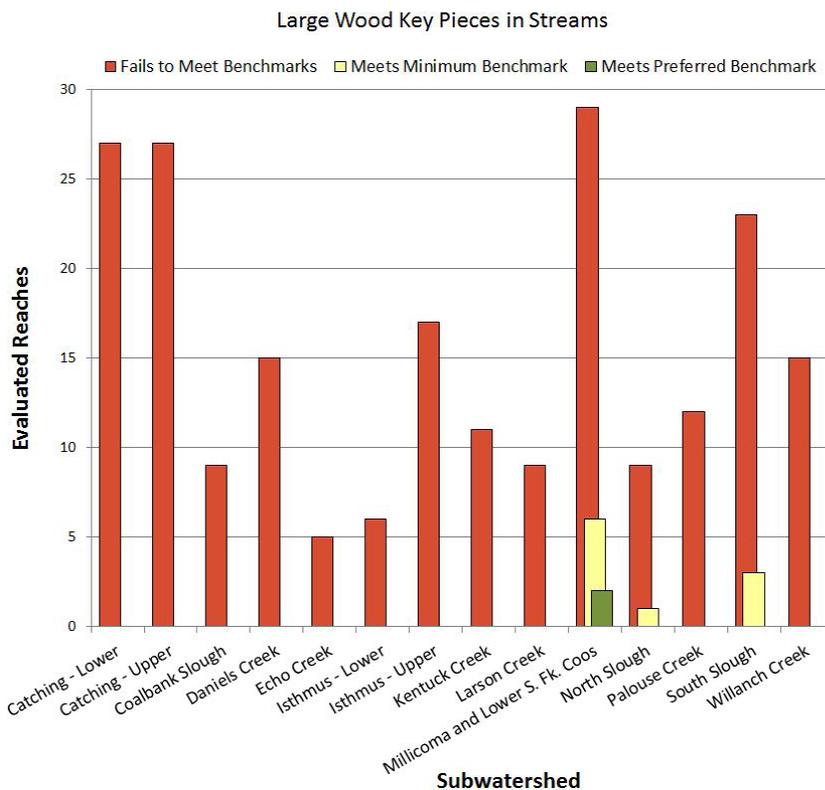
Figure 11. Distribution of evaluated stream reaches in the project area that met, exceeded, or did not meet ODFW habitat benchmarks for LWD key pieces in streams. Data: CoosWA 2006, 2008, 2011c; Cornu et al. 2012

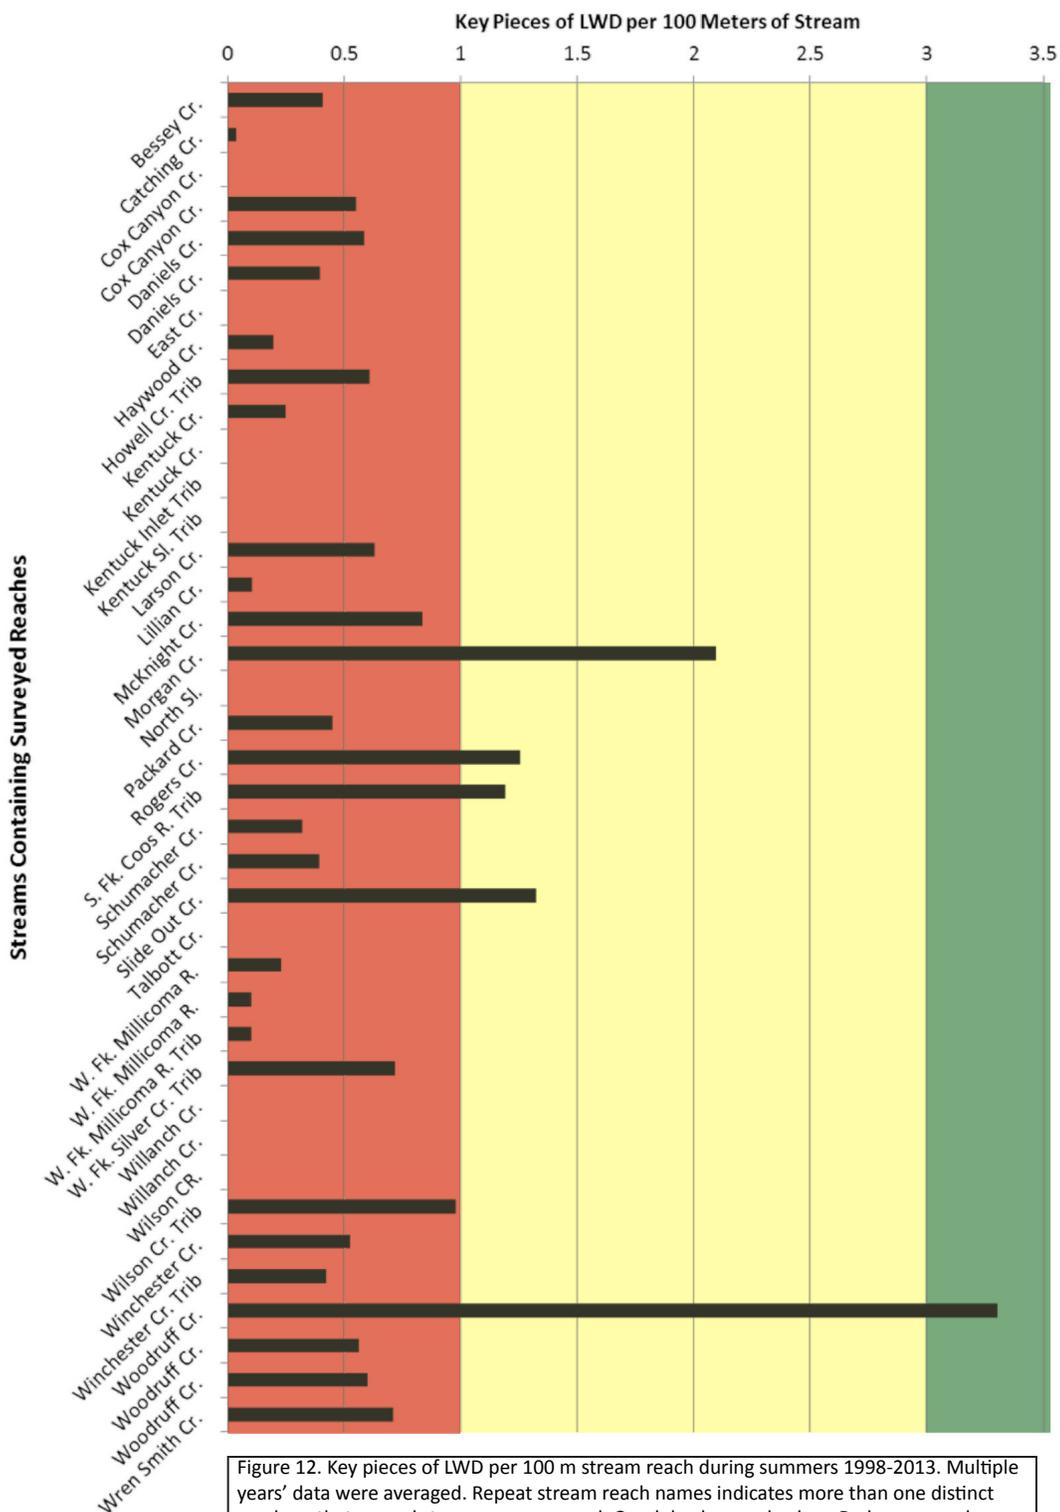
Key LWD Pieces in ODFW Summer Surveyed Reaches of the Coos Watershed, 1998-2013

Figure 12. Key pieces of LWD per 100 m stream reach during summers 1998-2013. Multiple years' data were averaged. Repeat stream reach names indicates more than one distinct reach on that named stream was surveyed. Graph background colors: Red zone- reach did not meet the 1 key piece/100 m minimum benchmark; Yellow zone- reach met the 1 key piece/100 m minimum benchmark but did not meet >3 key pieces/100 m preferred benchmark; Green zone- reach met or exceeded the >3 key pieces/100 m benchmark. Data: ODFW 2013.

CoosWA stream survey results suggest slightly better overall conditions compared with ODFW's summer surveys. As shown in Figure 12, the overwhelming majority of surveyed reaches (34 of 39, or 87%) failed to meet either ODFW benchmarks for LWD key pieces, 10% (4 reaches) met the minimum benchmark, and <3% (1 reach) met the preferred benchmark. Ten reaches had no key LWD pieces and only Woodruff Cr met the preferred criteria.

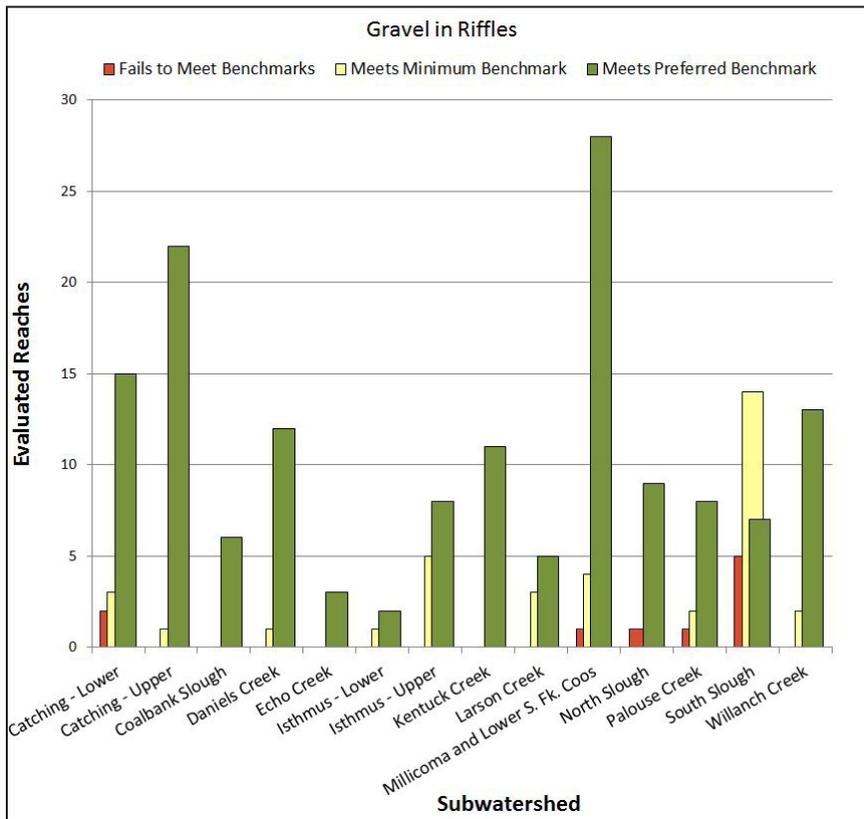
Figure 13. Distribution of evaluated stream reaches in the project area that met, exceeded, or did not meet ODFW habitat benchmarks for gravel content of riffles. Data: CoosWA 2006, 2008, 2011c; Cornu et al. 2012

As shown in Figure 13, of 195 reaches evaluated by the CoosWA for gravel in riffles, 18% (36) met the 15% gravel minimum benchmark, 76% (149) met the 35% gravel preferred benchmark, and 5% (10) failed to meet either benchmark. It should be noted that the majority of the reaches that failed to meet the minimum benchmark were located in the South Slough watershed. All stream reaches surveyed in seven subwatersheds (Daniel's Creek, Echo Creek, Upper and Lower Isthmus Slough, Kentuck Creek, Larson Creek, Wil-

lanch Creek, and Coalbank Slough) met either of ODFW’s riffle gravel benchmarks. Kentuck Creek, Echo Creek, and Coalbank subwatersheds particularly stand out in that all of their evaluated reaches met or exceeded the ODFW preferred benchmarks.

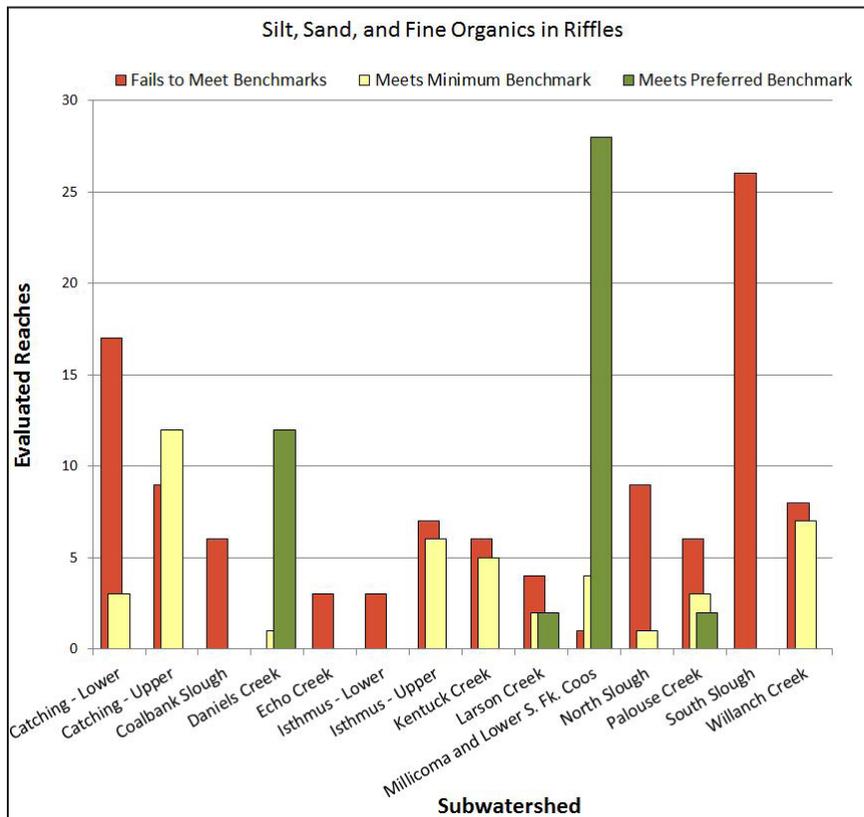
Figure 14. Distribution of evaluated stream reaches in the project area that met, exceeded, or did not meet ODFW habitat benchmarks for silt, sand, fines, and organic content of riffles. Data Source: CoosWA 2006, 2008, 2011c; Cornu et al. 2012

As shown in Figure 14, of 193 reaches evaluated by the CoosWA for silt, sand, and fine organics, 11% (21) met preferred benchmark levels, 32% (62) met the minimum benchmark, and 57% (110) failed to meet either benchmark. This suggests consistent problems with sedimentation in the project area, possibly stemming from erosion from unstable stream banks, especially those lacking a mature riparian plant community. Upstream, sedimentation may originate from access roads and steep slopes subject to episodic industrial timber production. The Daniels and Millicoma and lower South Fork Coos Rivers subwatersheds stand out as exceptions by consistently meeting preferred ODFW sedimentation benchmarks.

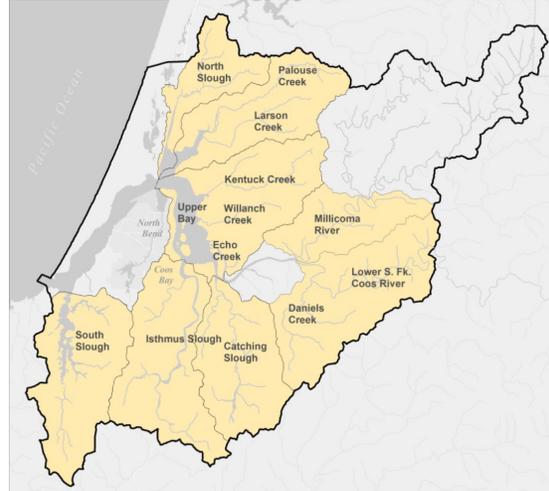
Figure 15. Subwatersheds evaluated by Coos Watershed Association for road-related sediments (shaded yellow) within the project boundaries (outlined in black). Data: CoosWA 2006, 2008, 2011c; Cornu et al. 2012

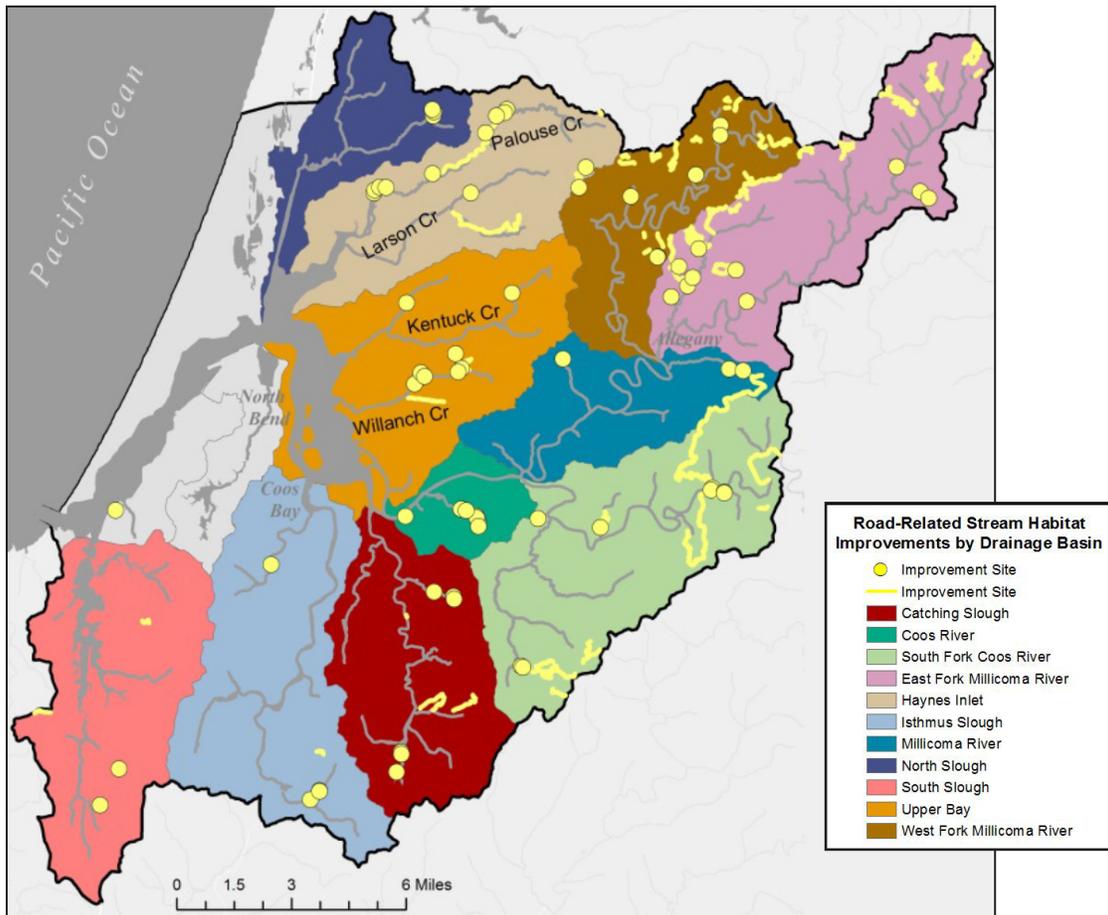
Figure 16. Road-related stream habitat improvements in the project area by drainage basin. Improvement site points include such things as new or replaced culverts, fords replaced with bridges, etc. Improvement site lines include surface drainage improvements along a road; erosion control; and other along-road improvements. Data: OWRI 2013

Nearly 90 road-related sediment and fish passage improvement projects have been completed in the project area from 1995-2013 (OWRI 2015)(Table 2, Figure 16). These projects have made over 41 miles of upstream habitat once again accessible to fish (Figure 17).

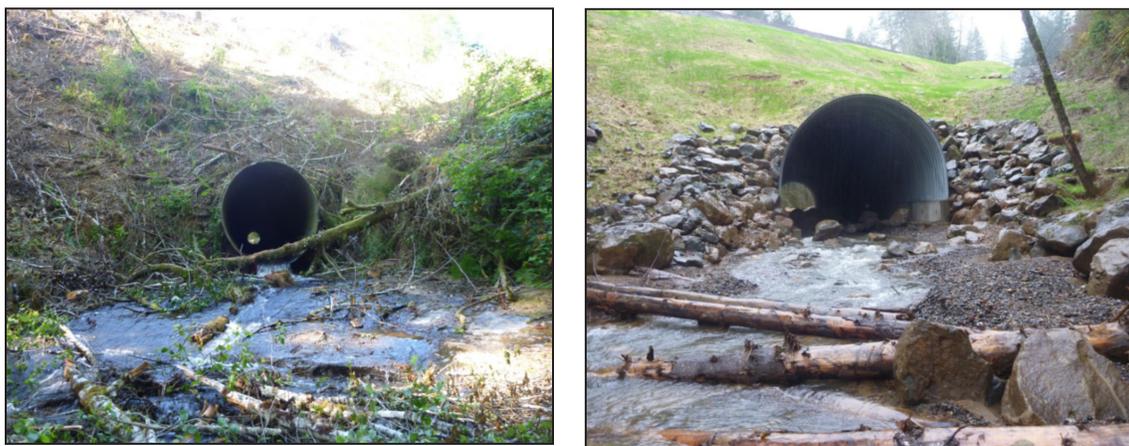
Figure 17. Undersized culvert with step blocked movement of Coho and Chinook to high quality upstream habitat (left). Culvert was removed and replaced with 26' wide arched steel set onto concrete footings (right), allowing natural stream habitat to be maintained through the 126' long passage. Source: CoosWA 2013

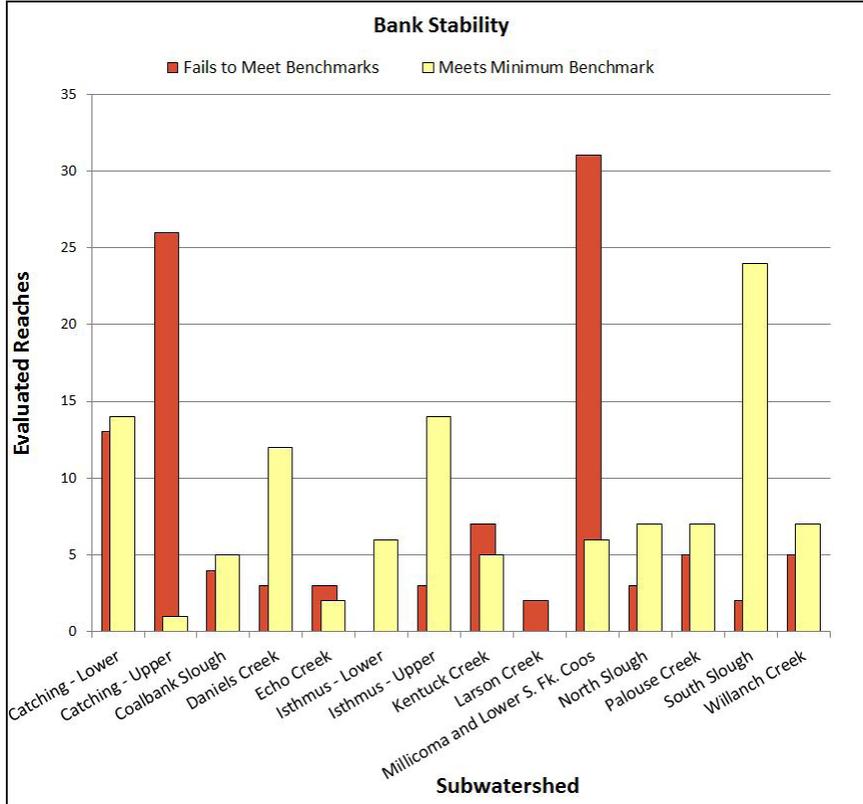
Figure 18. Distribution of evaluated reaches in the Coos watershed that met or did not meet USEPA habitat benchmarks for riparian bank stability. Note, there is no “Preferred benchmark” for bank stability, USEPA uses a pass/fail standard. Data: CoosWA 2006, 2008, 2011c; Cornu et al. 2012

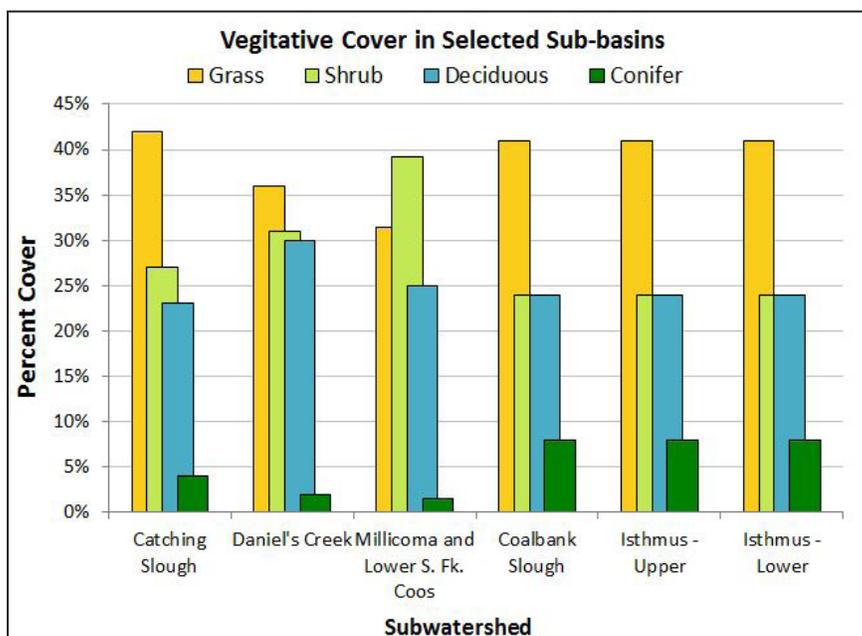
Figure 19. Distribution of riparian cover in evaluated stream reaches of the lower Coos watershed. Data: CoosWA 2008, 2011b

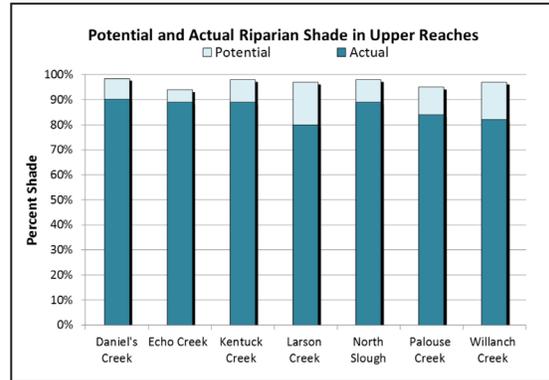
Figure 21. Actual and potential riparian shade cover of upper stream reaches in the lower Coos watershed. Data: CoosWA 2006, 2008

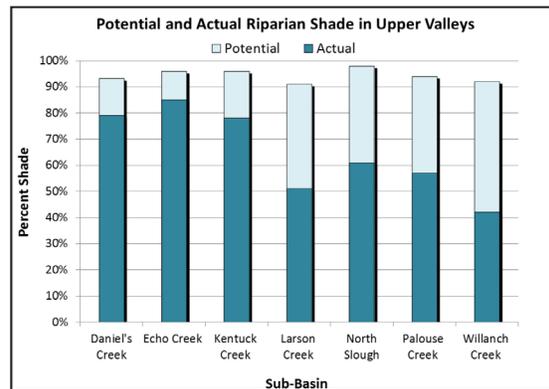
Figure 22. Actual and potential riparian shade cover of upper valleys in the lower Coos watershed. Data: CoosWA 2006, 2008

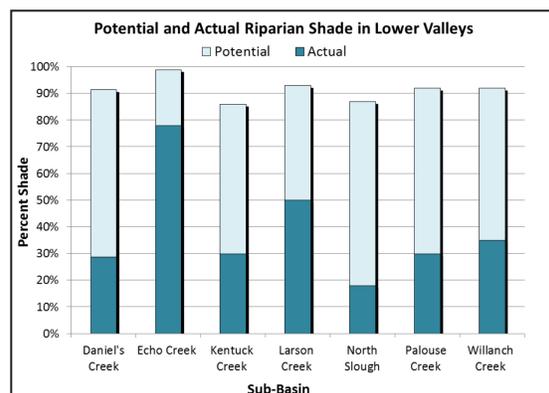
Figure 23. Actual and potential riparian shade cover of lower valleys in the lower Coos watershed. Data: CoosWA 2006, 2008

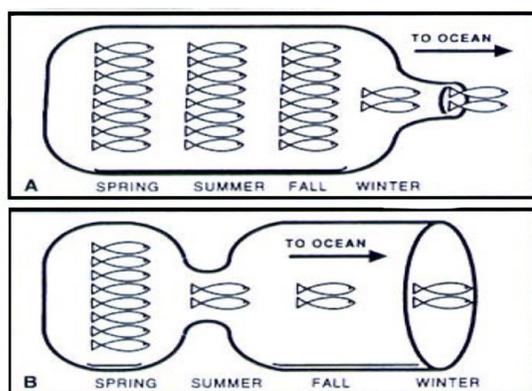
Figure 26. Bottlenecks identified by the HLFM model, and their potential affects on Coho populations. A: Winter habitat bottleneck; B: Summer habitat bottleneck. Source: Reeves et al. 1991

The HLFM bottleneck illustrated in Figure 26 is a habitat limitation that occurs (A) during winter juvenile Coho salmon migration; and (B) during summertime juvenile Coho salmon migration. A manager facing scenario A might consider devoting resources to off-channel

pools that give Coho salmon refuge from high stream flow events. Faced with scenario B, managers might place a higher priority on improving total pool area and on strategies for maintaining or improving cold water refugia in Coho streams.

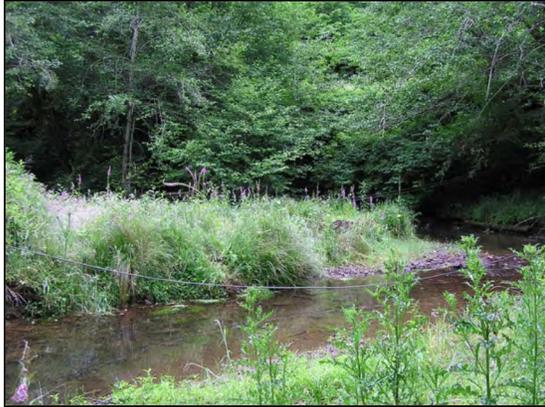
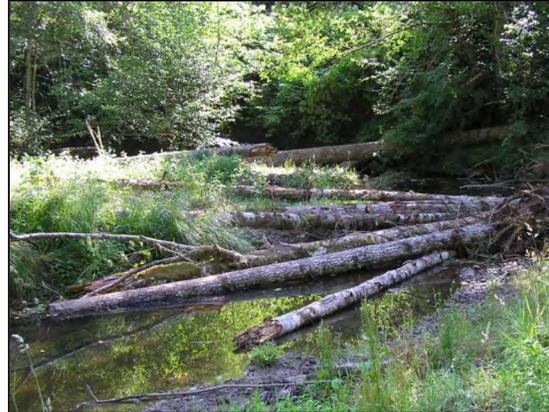
Figure 27. Tributary of the West Fork Millicoma River before (left) and after (right) intentional placement of large wood pieces. Source: CoosWA 2009

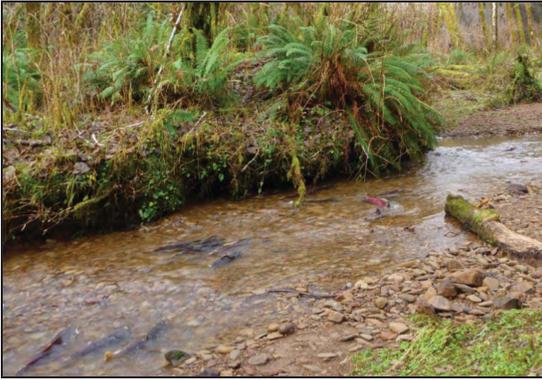
Figure 28. Coho building redds in gravel in a coastal Oregon stream. Source: CoosWA 2011a

salmon eggs are deposited and fertilized)(Figure 28). Each salmon species prefers gravel of different sizes, allowing multiple species to reproduce in the same stream reach (Foster et al. 2001). It is therefore important that riffles contain sufficient amounts of gravel to support salmonid reproduction. Koski (1966) conducted studies in three Oregon streams which indicated that the composition of gravel within a redd was the single most important factor affecting the emergence of newly hatched Coho salmon.

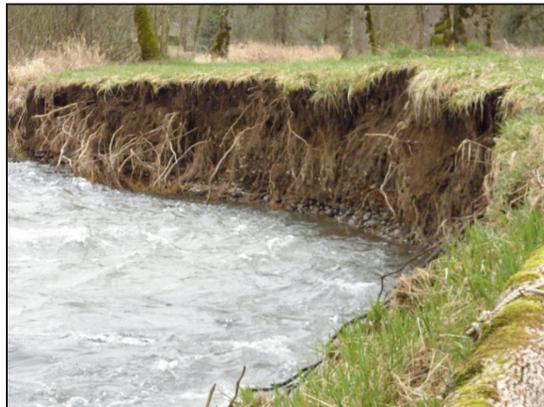
Figure 29. An eroding stream bank on the Oregon coast, which has been facilitated by the removal of stream bank vegetation. Source: Clackamas County Soil and Water Conservation District 2015

The causes of bank instability can be natural or the result of human activity (particularly the clearing of streamside vegetation)(Figure 29). When riparian areas undergo human disturbances like development, agriculture, timber harvest, and fires, they often lack the plant cover necessary to stabilize stream banks. In fact, plant cover is so important to bank stabilization that 99% of uncovered banks in the Catching Slough and Daniels Creek assessments were considered unstable (CoosWA 2008). To become stable, a harvested riparian area must be replanted. In coastal Oregon, replanted stream banks will be considered stable after about 30 years of riparian vegetation regrowth (CoosWA 2008). According to USEPA, healthy watersheds cannot have more than more than 10% unstable (typically uncovered) banks; in some of our watersheds, unstable banks make up twice that percentage (USEPA 2012; CoosWA 2006, 2008, 2011c; Cornu et al. 2012).
